Case Study

Food Manufacturing Facilities

This major food manufacturing facility was experiencing issues with performance of its air delivery system. MANN+HUMMEL were asked to help.

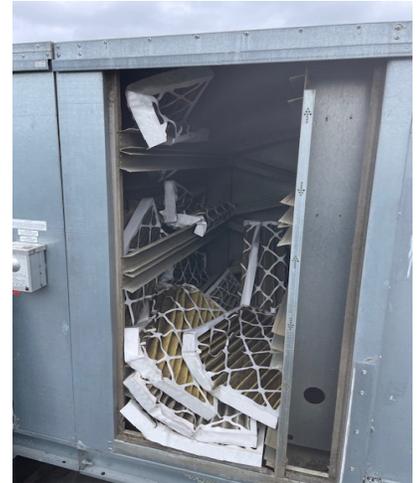
The food manufacturing facility also produces an excess amount of oil that is exhausted on the facility's roof. The oil clogs the filters, therefore requiring the plant to change their filters as often as every 2 months. Moisture was also a concern for the facility when bringing in outside air. The cardboard frames on the air filters they were using became soggy and as dirt and oil accumulated in the media, the pleated filter failed catastrophically in less than 2 months (see image included).

In addition, the food manufacturing facility also found that their air filters had been shifted of place. This shift occurred due to the moisture causing a catastrophic failure of the filter frame, creating bypass through the space between the pleats given the lack of a tight seal, which meant they were not actively filtering out particles and contaminants entering their building. This created potentially hazardous conditions for their food manufacturing processes and the products they were producing.

BEFORE M+H FILTERS

They knew they needed to try a new strategy and thought to try the industry known Tri-Dek 2 ply panel. When speaking to the MANN HUMMEL distributor who audited the facility after necessary filtration changes were made, the distributor said, "The Tri-Dek link gives you true system efficiency. The links allow for no gaps and therefore block all contaminants from coming through." After using the Tri-Dek 2 ply panel, the food manufacturing facility's HVAC system efficiency and filtration improved due to the Tri-Dek filters' 'self-sealing' properties, thus eliminating air bypass and reducing the amount of contaminants in the air. The Tri-Dek filters' moisture-resistant properties also helped due to its ability to handle their excess oil and moisture issues.

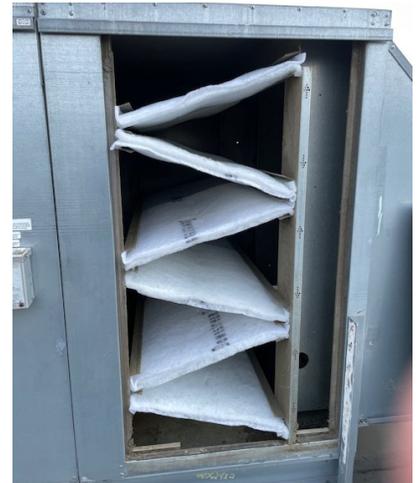
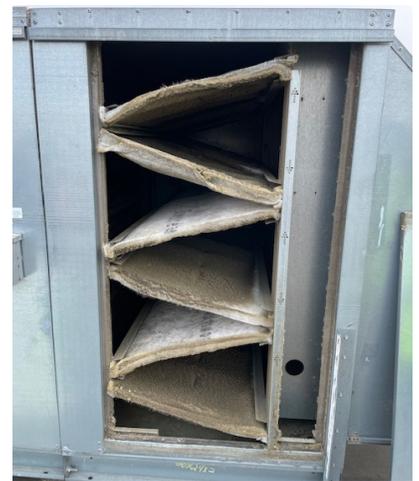
When speaking to the MANN+HUMMEL distributor who audited the facility and after necessary filtration changes were made the distributor said, "The Tri-Dek link gives you true system efficiency. The links allow for no gaps and therefore block all contaminants from coming through."

AFTER M+H FILTERS

Now, the food manufacturing plant is keeping its products safe and secure from airborne contaminants, efficiently maintaining their air filtration systems.
