Case Study

Food Manufacturing Facilities

This major food manufacturing facility was experiencing issues with performance of its air delivery system. MANN+HUMMEL was asked to help.

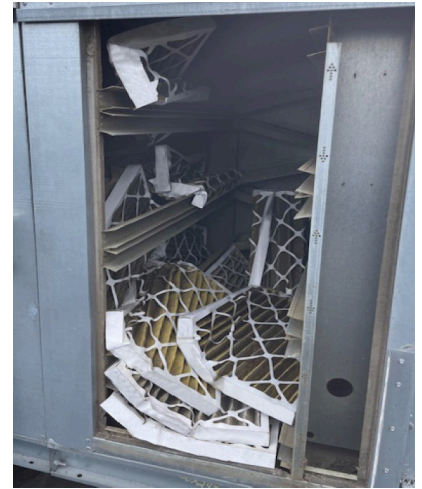
BEFORE M+H FILTERS

The food manufacturing facility also produces an excess amount of oil that is exhausted on the facility's roof. The oil clogs the filters, therefore requiring the plant to change their filters as often as every 2 months. Furthermore, the food manufacturing facility found that their air filters had been completely blown out of place, leading to the conclusion that moisture was an additional concern for the facility when bringing in outside air.

The integrity of the filters cardboard frames were compromised due to the combination of oil and moisture, hence the pleated filters failed catastrophically in less than 2 months (see image included). This created bypass through the space between the pleats given the lack of a tight seal, which meant the filters were not actively filtering out particles and contaminants entering the building. The combination of these factors allowed for potentially hazardous conditions in their food manufacturing processes and the products being produced.

The distributor knew they needed to try a new strategy and recommended the industry known Tri-Dek 2 ply panel filters. When speaking to the MANN+HUMMEL distributor who audited the facility after necessary filtration changes were made, the distributor said, "The Tri-Dek filters provide true system efficiency due to the way the filters completely seal the filter housing, eliminating air bypass. This protects the equipment and can provide improved air quality downstream." After using the Tri-Dek 2 ply panel filters, the food manufacturing facility's HVAC system efficiency and filtration improved. These improvements were due to the Tri-Dek filters 'self-sealing' properties, thus eliminating air bypass and reducing the amount of contaminants in the air. The Tri-Dek filters' moisture-resistant properties also helped as it was able to handle their excess oil and moisture issues.
